SINCLAIR QL SERVICE MANUAL

# QL Service Manual

Prepared by THORN (EMI) DATATECH LTD  
for SINCLAIR RESEARCH LTD

OCTOBER 1985

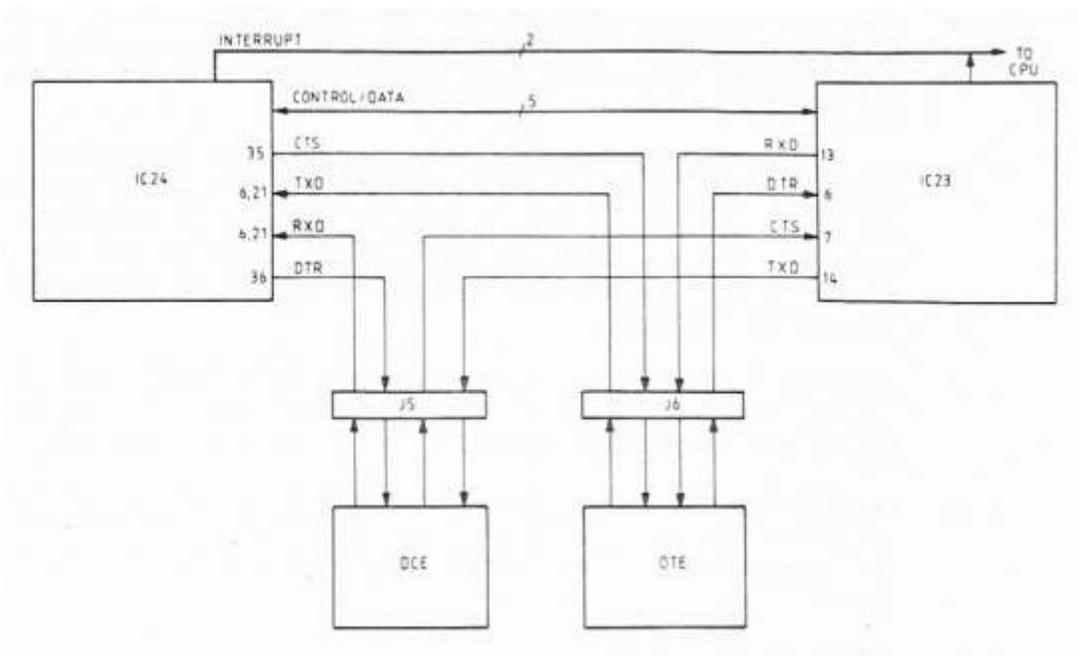
FIGURE 1.1 RS232 LINK

4.9 Consider the QL as the DTE. Both DTE and DCE are switched on and have their DTR signals asserted. CTS and DTR (Clear to Send, Data Terminal Ready) do not form a handshake pair but are similar signals going in opposite directions. Serial data is transmitted by IC23 via driver IC25/6 and received by line receiver IC26/11. From IC26/11 data is fed to NAND gate IC27/9, pin 10 of which is set to the high state by the program, and input to IC24 pins 6 and 21 via IC27/11.

4.10 On receipt of a start bit, IC24 is interrupted, and a subroutine clocks in the data bits, synchronised by the baud rate generator. The data, up to about 20 bytes per RS232 channel, is then buffered in IC24. At the same time, IC24 receives commands (and sends reports) via the serial link with IC18 which is controlled by IC23. When IC24 receives a command from IC18 to empty one of its buffers, it does so, down the serial link via IC23.

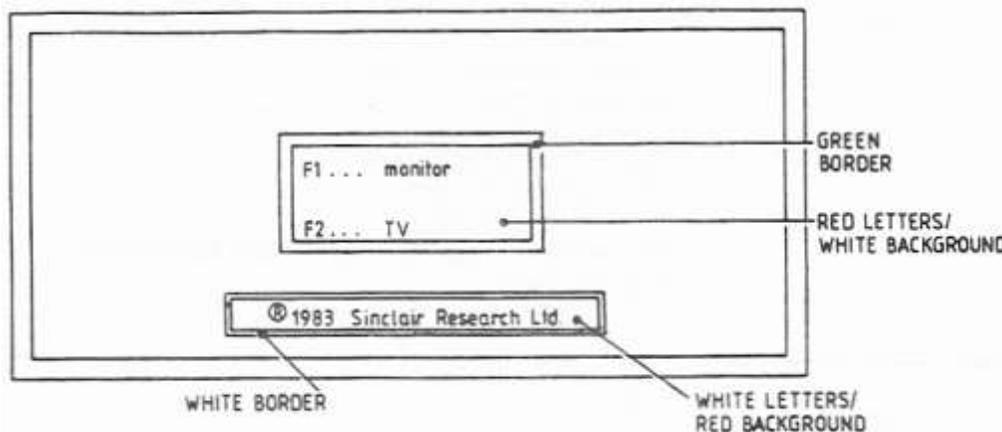
3.1.1 Connect the QL and power-up as if for normal use; check that the yellow 'power on' LED is illuminated and the following message is displayed on both screens:

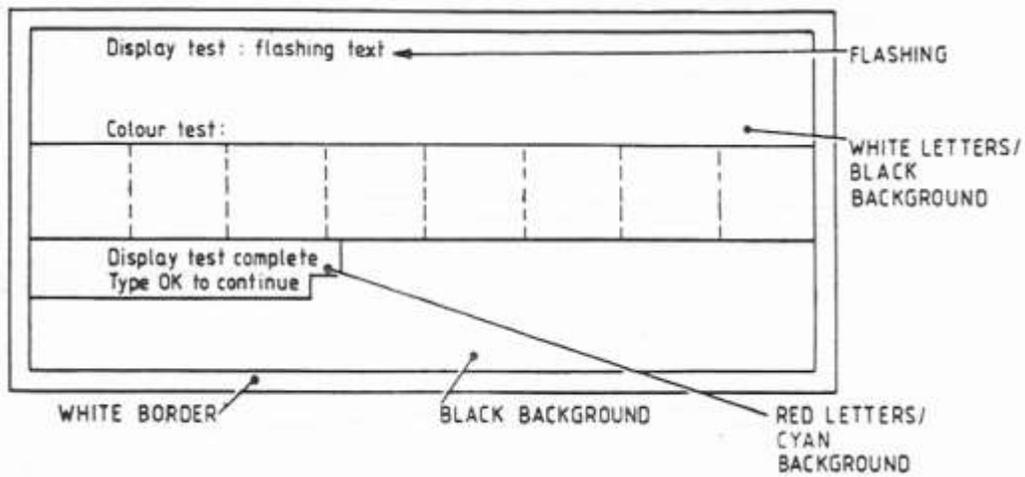
3.2.1 After the message to load a blank cartridge into MDV2 is displayed, both screens should clear and then display the following colour test card.

NOTE: On each colour bar the word 'Test' should be written 8 times, once in each of the following colours from top to bottom  
Black - Blue - Red - Magenta - Green - Cyan - Yellow - White

3.2.2 Check that the colours on the monitor are the same as those on the TV; check that the flashing text is satisfactory; type OK to proceed.

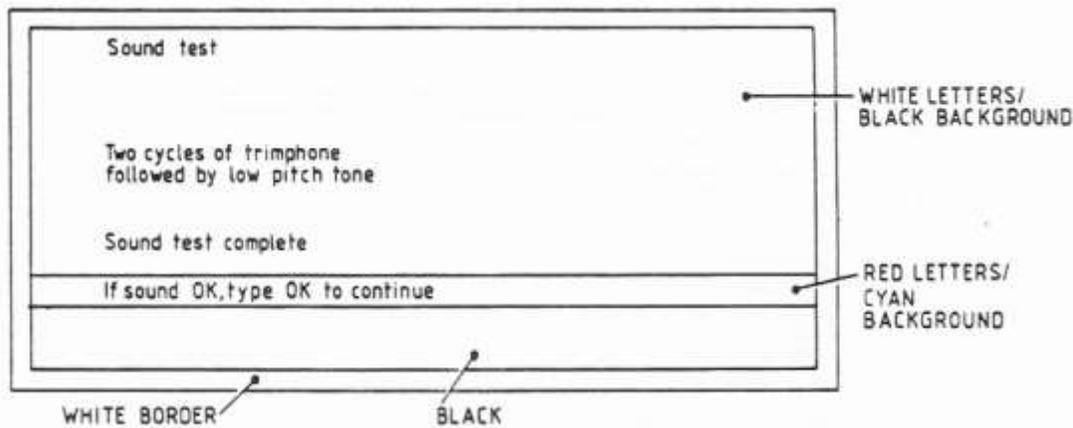
3.3.1 Check that the following is displayed:

3.3.2 After hearing two cycles of trimphone followed by the low pitch tone, type OK to continue.

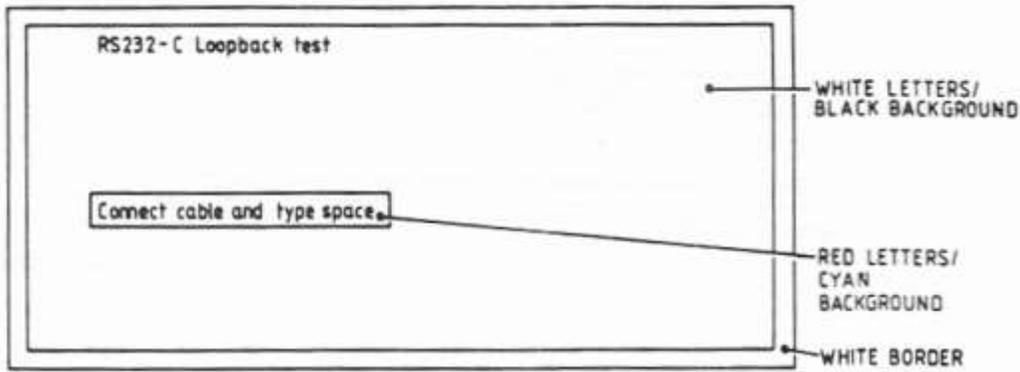
3.5.1 Check that the following is displayed:

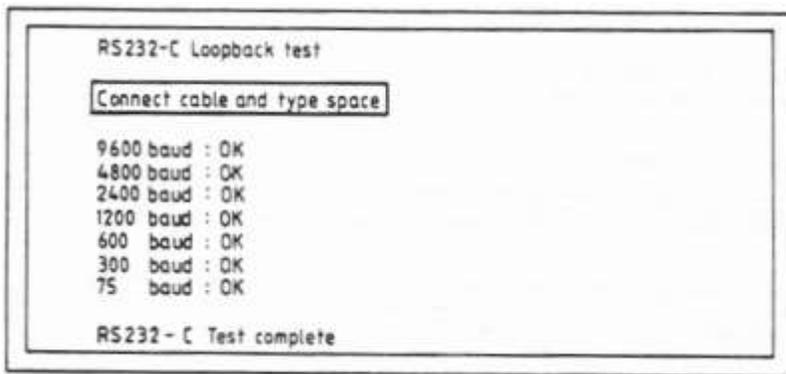
3.5.2 Connect the loopback cable in the QL's SER1 and SER2 sockets and press the space bar; the following message should be temporarily displayed:

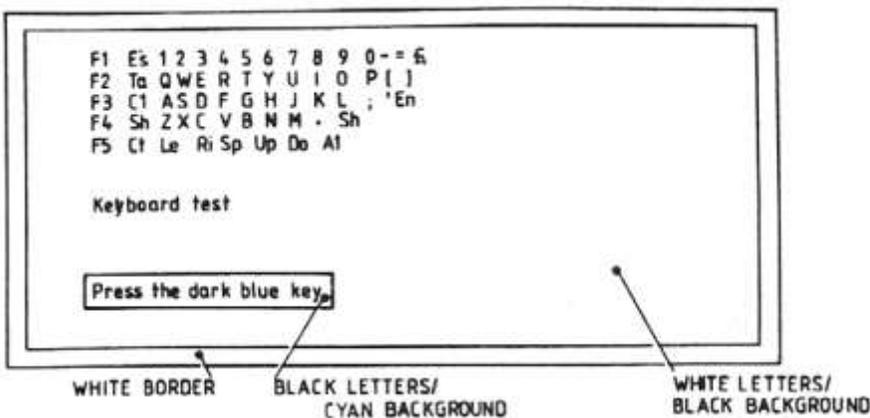
3.6.1 Check that the following is displayed:

3.6.2 Press the key indicated by a dark blue background on the display. The blue background should be key green and move onto the next key. Press all keys in sequence and note that on pressing the ALT key the message: 'keyboard test complete' is displayed momentarily.

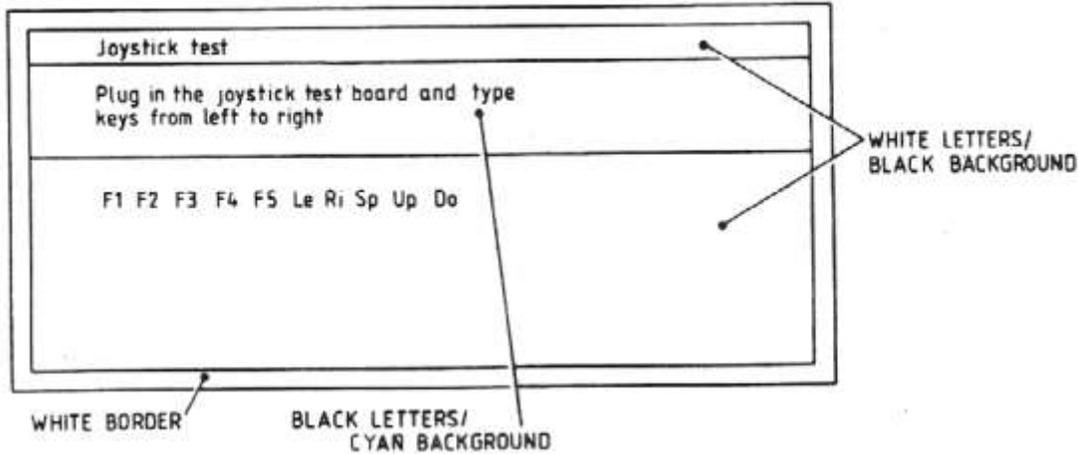
3.7.1 Check that the following is displayed:

3.7.2 Ignore the message concerning the joystick test board (intended for factory use only). Instead press the F1, F2, F3, F4 and F5 keys on the keyboard followed by the Left, Right, Space, Up and Down keys on the keyboard. The background colour of each key on the display should change from blue to green as in the keyboard test. On pressing the last key the message 'joystick test complete1 is displayed momentarily.

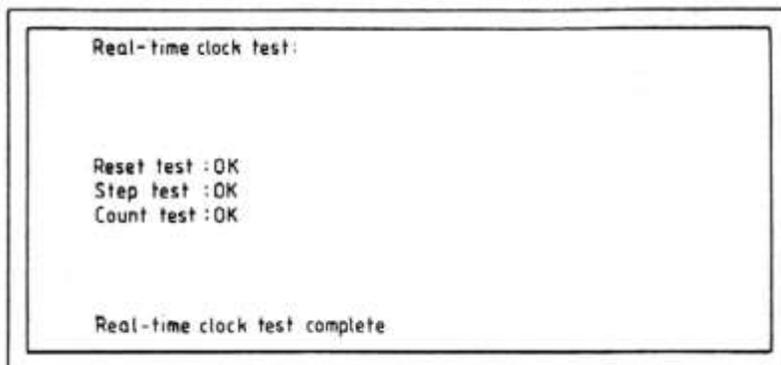
3.8.1 Check that the following are displayed momentarily:

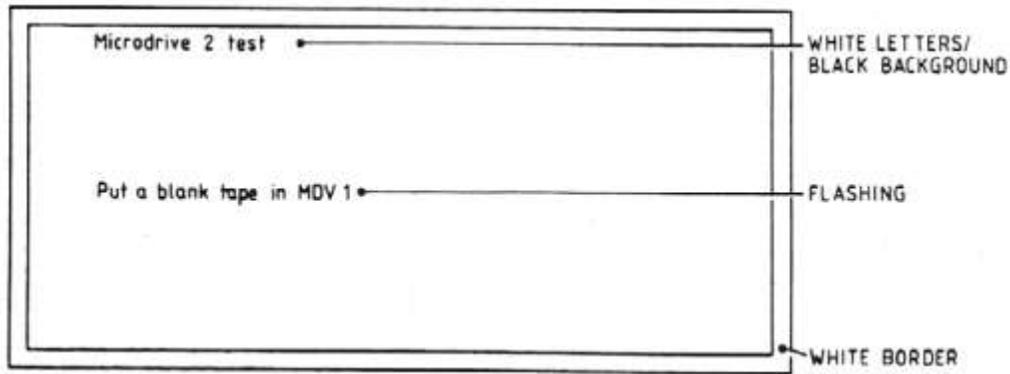
3.9.1 Check that the following message is displayed and that MDV2 starts to run and the corresponding red LED is illuminated.

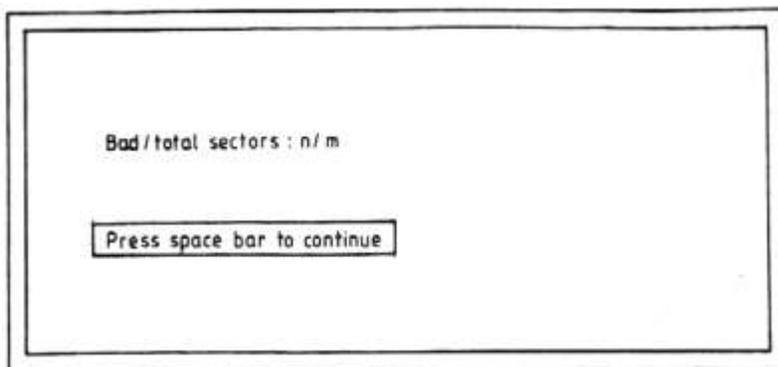
3.9.3 After a short delay the following message should be displayed:

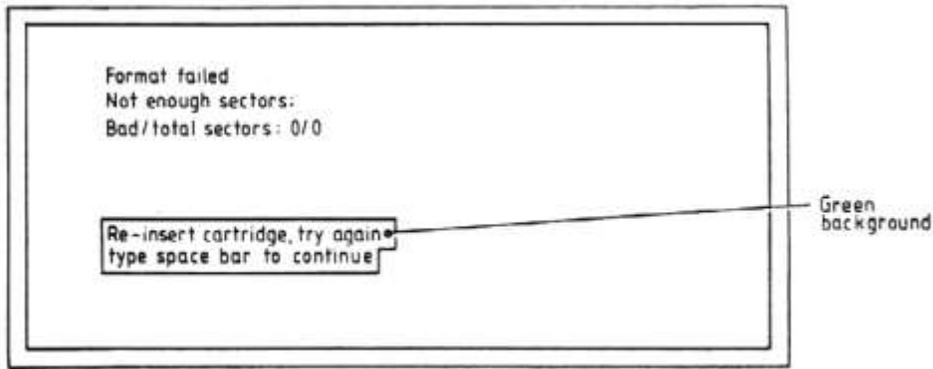
3.11.1 If during either microdrive test, the cartridge is not inserted correctly the following message is displayed in red:

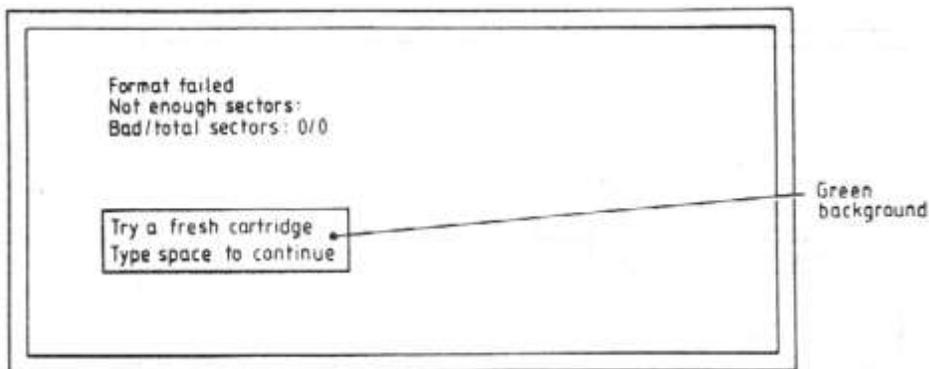
3.11.2 Re-insert the cartridge in MDV1 or MDV2 as appropriate and press the space bar. If the test fails a second time the following message is displayed.

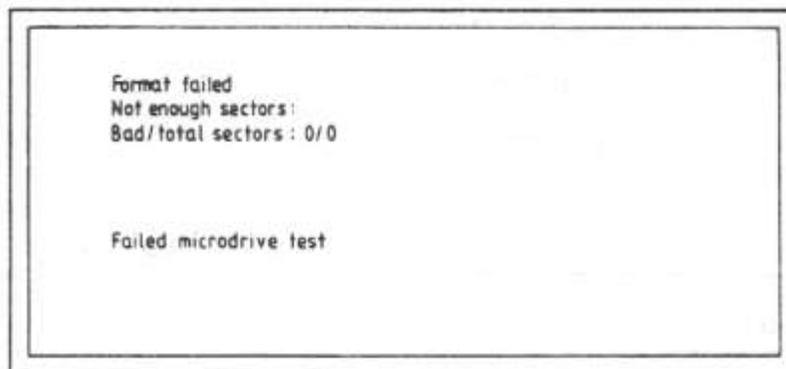
3.11.4 If the test fails a fourth time, the following message is displayed and the test is abandoned.

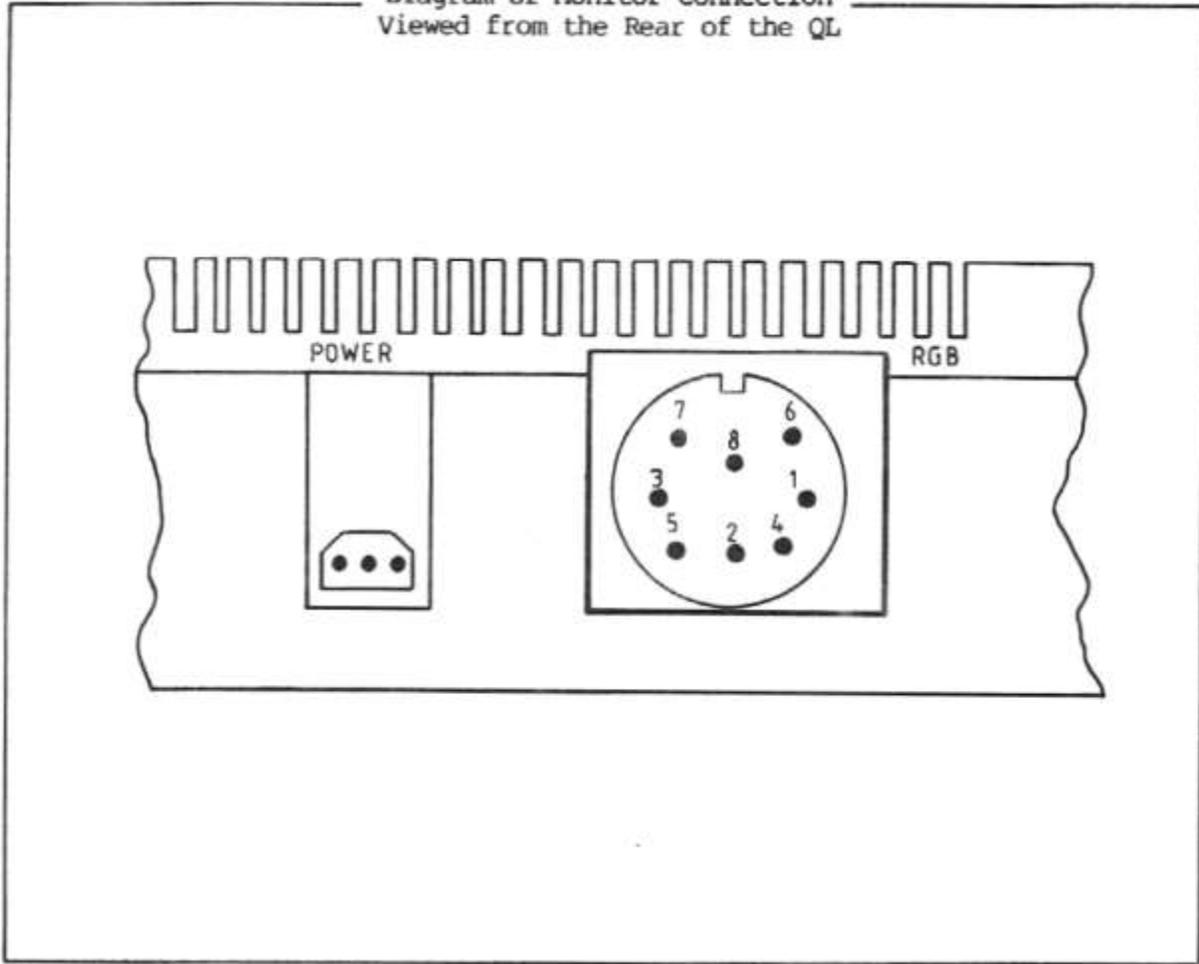
Diagram of Monitor Connection  
Viewed from the Rear of the QL

1.5 A composite PAL monitor, or the composite video input on some VCRs may work with the QL. Only pins 2 (ground) and 1 (composite PAL) need to be connected via a cable, to the monitor or VCR.

Pin	Function	Signal	Wire Colour	Signal Level
1	PAL	Composite Pal	Orange	1V pk-pk into 75 ohm
2	GND	Ground	Green	
3	VIDEO	Composite Mono Video	Brown	1V pk-pk into 75 ohm
4	CSYNC	Composite Sync	Yellow	0 to 5V TTL (active low)
5	VSYNC	Vertical Sync	Blue	0 to 5V TTL (active high)
6	GREEN	Green	Red	0 to 5V TTL (active high)
7	RED	Red	White	0 to 5V TTL (active high)
8	BLUE	Blue	Purple	0 to 5V TTL (active high)
