sinclair

QL

Service
Manual

OCTOBER 1985

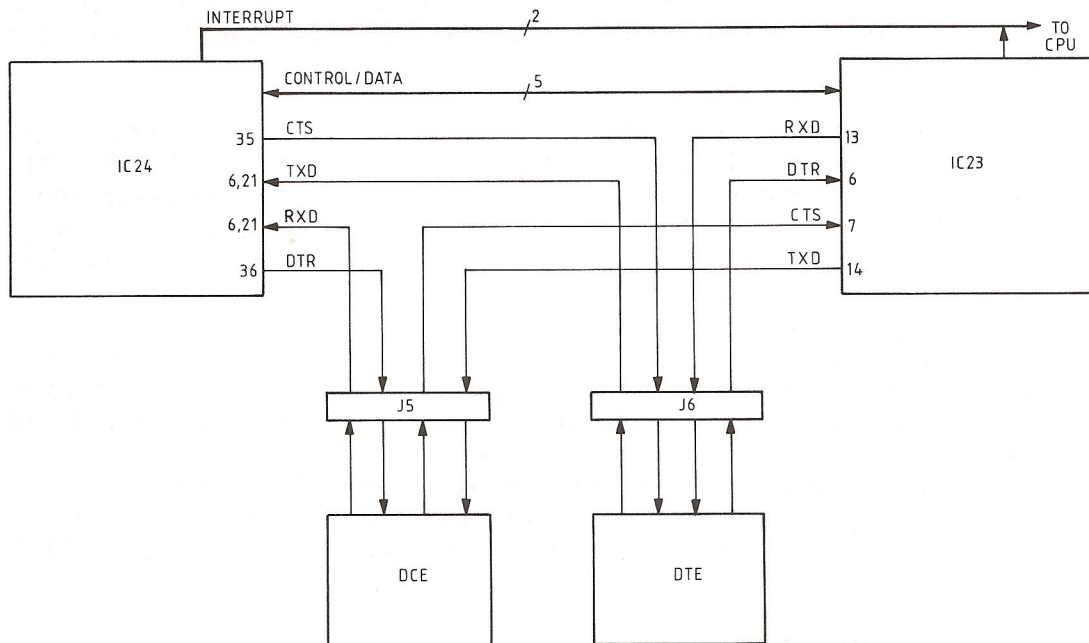
FIGURE 1.1 RS232 LINK

- 4.8 The RS232 interface uses an 11-bit ASCII data frame, viz. one start bit, eight data bits and two stop bits comprise one character. Two stop bits are always sent but the interface receives compatibly with one except at 9600 baud, where one and a half stop bits are required. Data is transmitted asynchronously in the full duplex mode.

- 4.9 Consider the QL as the DTE. Both DTE and DCE are switched on and have their DTR signals asserted. CTS and DTR (Clear to Send, Data Terminal Ready) do not form a handshake pair but are similar signals going in opposite directions. Serial data is transmitted by IC23 via driver IC25/6 and received by line receiver IC26/11. From IC26/11 data is fed to NAND gate IC27/9, pin 10 of which is set to the high state by the program, and input to IC24 pins 6 and 21 via IC27/11.

- 4.10 On receipt of a start bit, IC24 is interrupted, and a subroutine clocks in the data bits, synchronised by the baud rate generator. The data, up to about 20 bytes per RS232 channel, is then buffered in IC24. At the same time, IC24 receives commands (and sends reports) via the serial link with IC18 which is controlled by IC23. When IC24 receives a command from IC18 to empty one of its buffers, it does so, down the serial link via IC23.

9.1 A good simple test of the equipment may be carried out by connecting a loopback cable to the RS232 interface connectors J5 and J6 and instructing them to talk to each other. The technique for receiving RS232 involves the data passing through the IPC, through ZX8302 and back onto the processor data bus. If this functions correctly it is close to a guarantee that the whole system is functional.

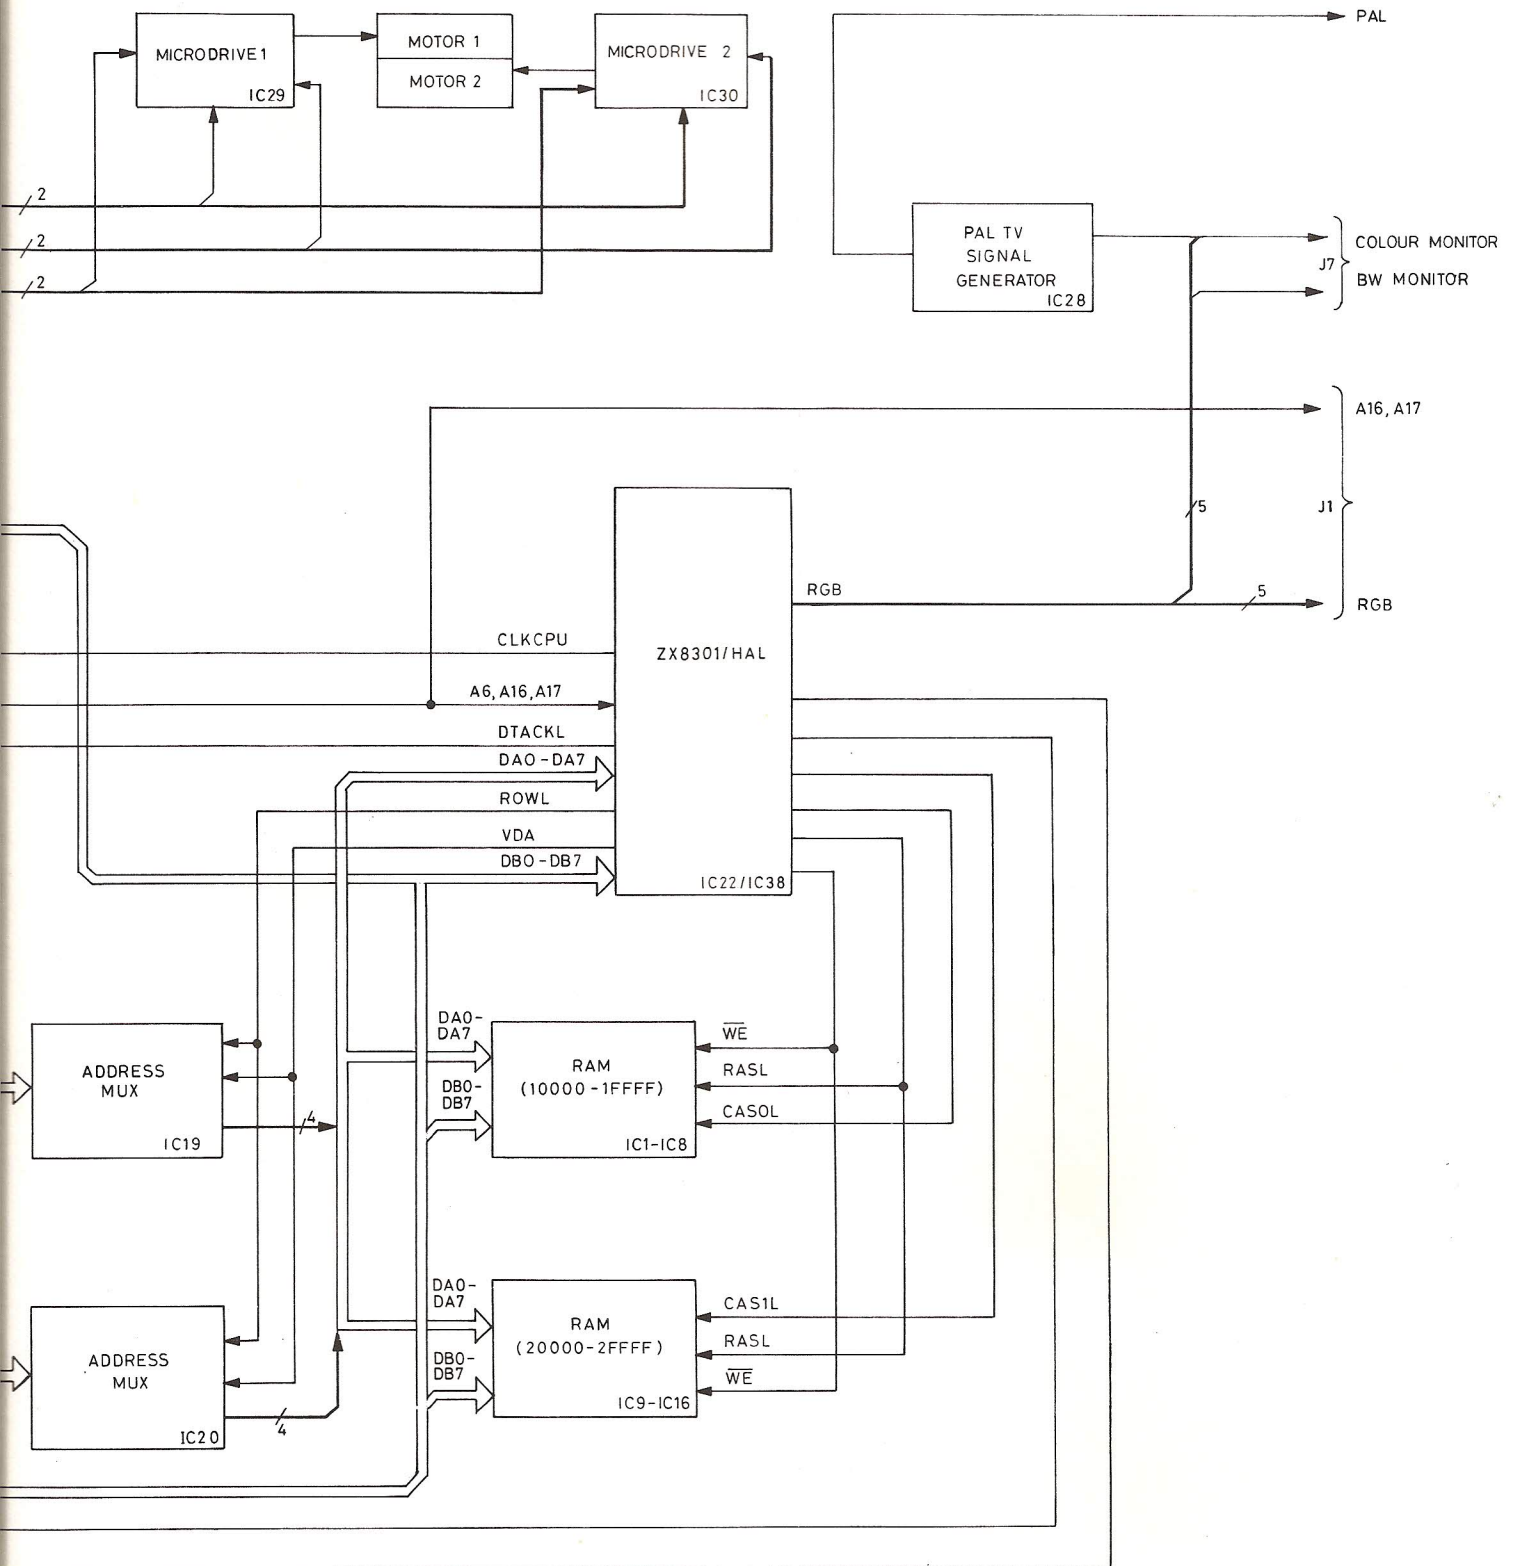
FIGURE 1.3 QL BLOCK DIAGRAM

- 2.1 The architecture of the QL shown in Figure 1.3 incorporates much that is typical of microcomputer systems, but certain innovations make it atypical. Two microprocessors, an Intel 8049 and a Motorola 68008 are used, and the availability of 128k of DRAM plus a minimum of 200k on the two microdrives provides unusual storage facilities. The 8049 is designated the Intelligent Peripheral Controller (IPC) and the 68008 is the CPU. Two additional semi-custom ICs ZX8301 and ZX8302 control defined areas of the system, under the supervision of the CPU.

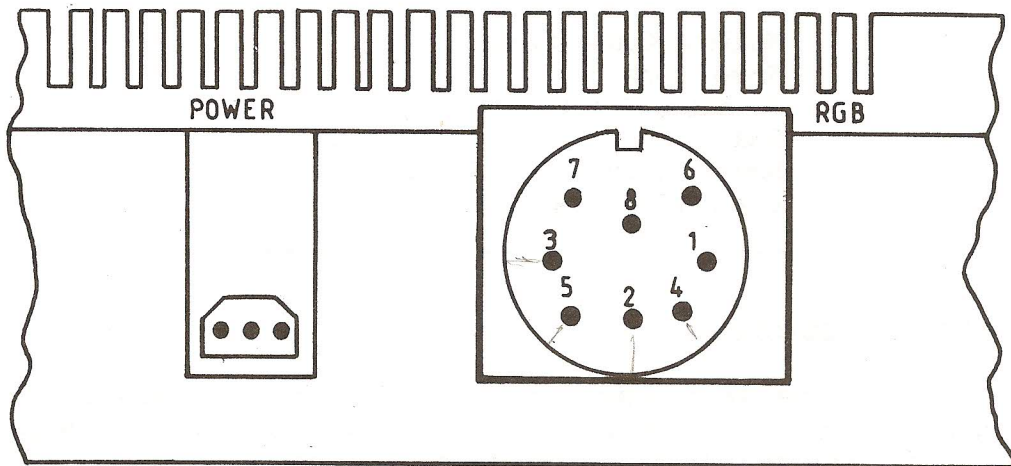
Diagram of Monitor Connection
Viewed from the Rear of the QL

- 1.5 A composite PAL monitor, or the composite video input on some VCRs may work with the QL. Only pins 2 (ground) and 1 (composite PAL) need to be connected via a cable, to the monitor or VCR.

Pin	Function	Signal	Wire Colour	Signal Level
1	PAL	Composite Pal	Orange	1V pk-pk into 75 ohm
2	GND	Ground	Green	
3	VIDEO	Composite Mono Video	Brown	1V pk-pk into 75 ohm
4	CSYNC	Composite Sync	Yellow	0 to 5V TTL (active low)
5	VSUNC	Vertical Sync	Blue	0 to 5V TTL (active high)
6	GREEN	Green	Red	0 to 5V TTL (active high)
7	RED	Red	White	0 to 5V TTL (active high)
8	BLUE	Blue	Purple	0 to 5V TTL (active high)

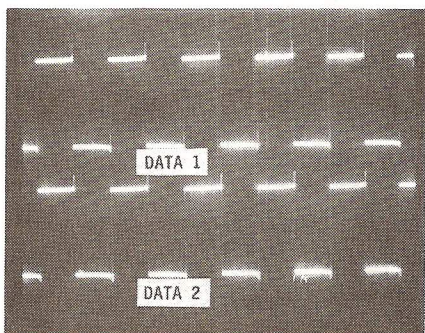
FIG D1

100 KHZ WRITE DATA 1 AND 2

5μs/DIV 2V/DIV

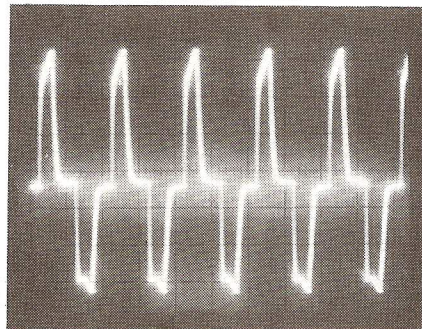
FIG D2

ULA PINS 4 AND 5: WRITE 100 KHZ

5μs/DIV 1V/DIV DIFFERENTIAL CH1 AND CH2 (INV)

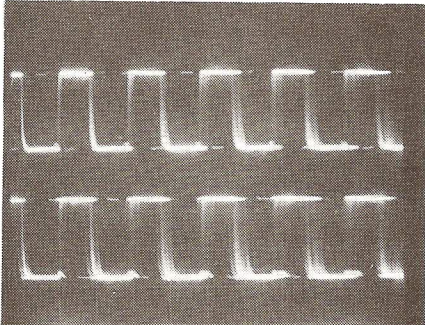
FIG D3

DATA 1 AND 2 : DURING READ 100 KHZ

5μs/DIV 2V/DIV (SHADOW DUE TO POOR ROLLER)

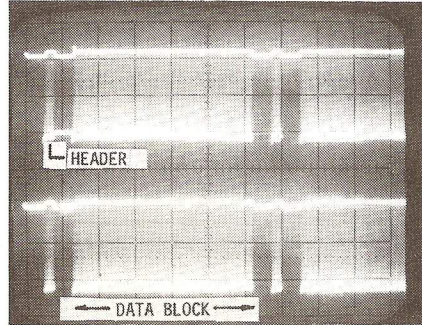
FIG D6

DATA 1 AND 2 : DURING FORMAT (READING)

0.2ms/DIV 2V/DIV

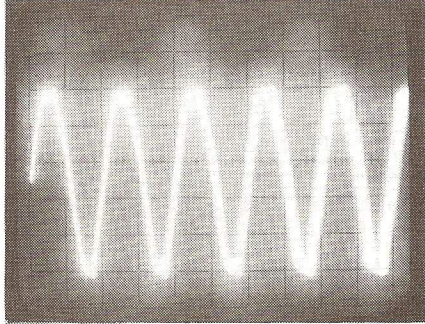
FIG D4

ULA PINS 4 AND 5 READ 100 KHZ

5μs/DIV 50mV/DIV DIFFERENTIAL CH1 and 2 (INV)

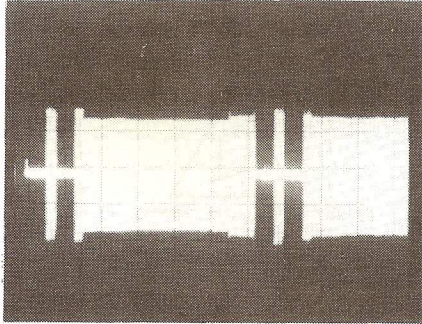
FIG D7

ULA PIN 1 : DURING FORMAT (READING)

0.2ms/DIV 0.2V/DIV

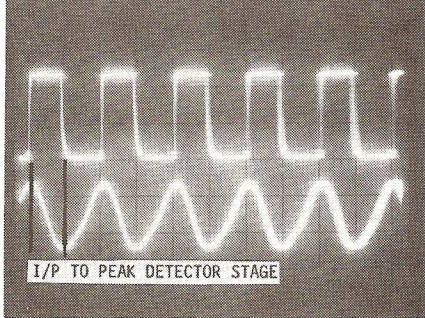
FIG D5

READ 100 KHZ

DATA 1
2V/DIV
5μs/DIV
ULA PIN 2
0.2V/DIV
5μs/DIV

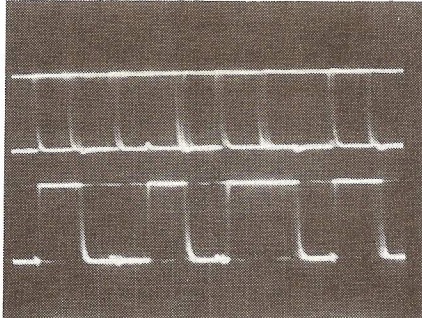
FIG D8

DATA 1 AND 2 : DURING FORMAT (READING)

5μs/DIV 2V/DIV

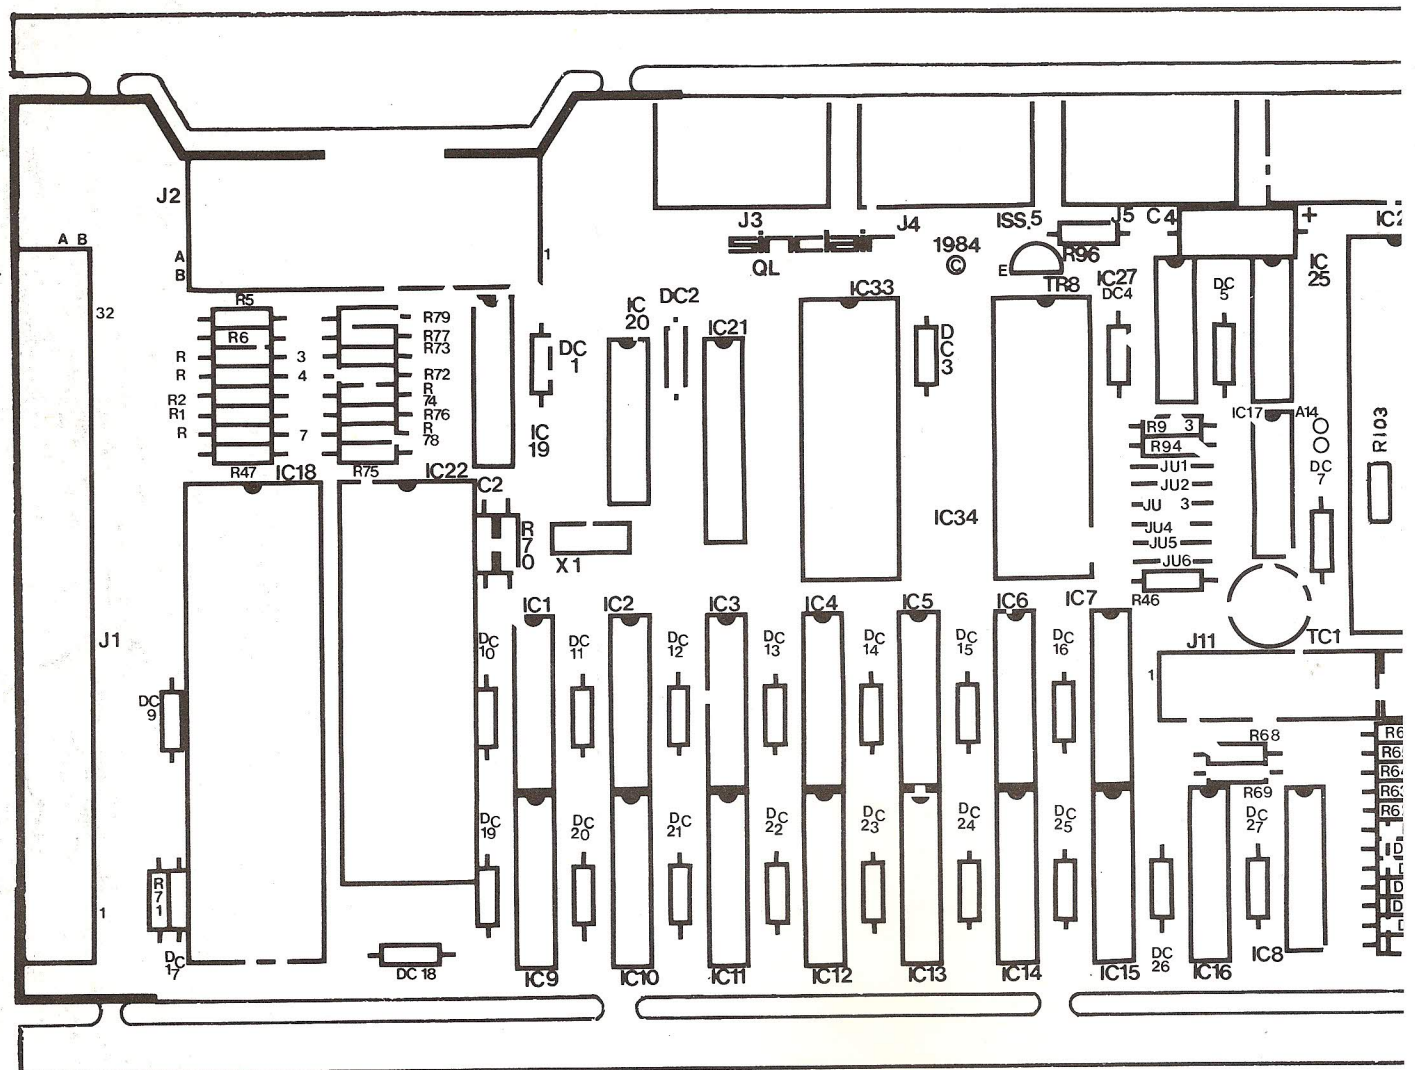
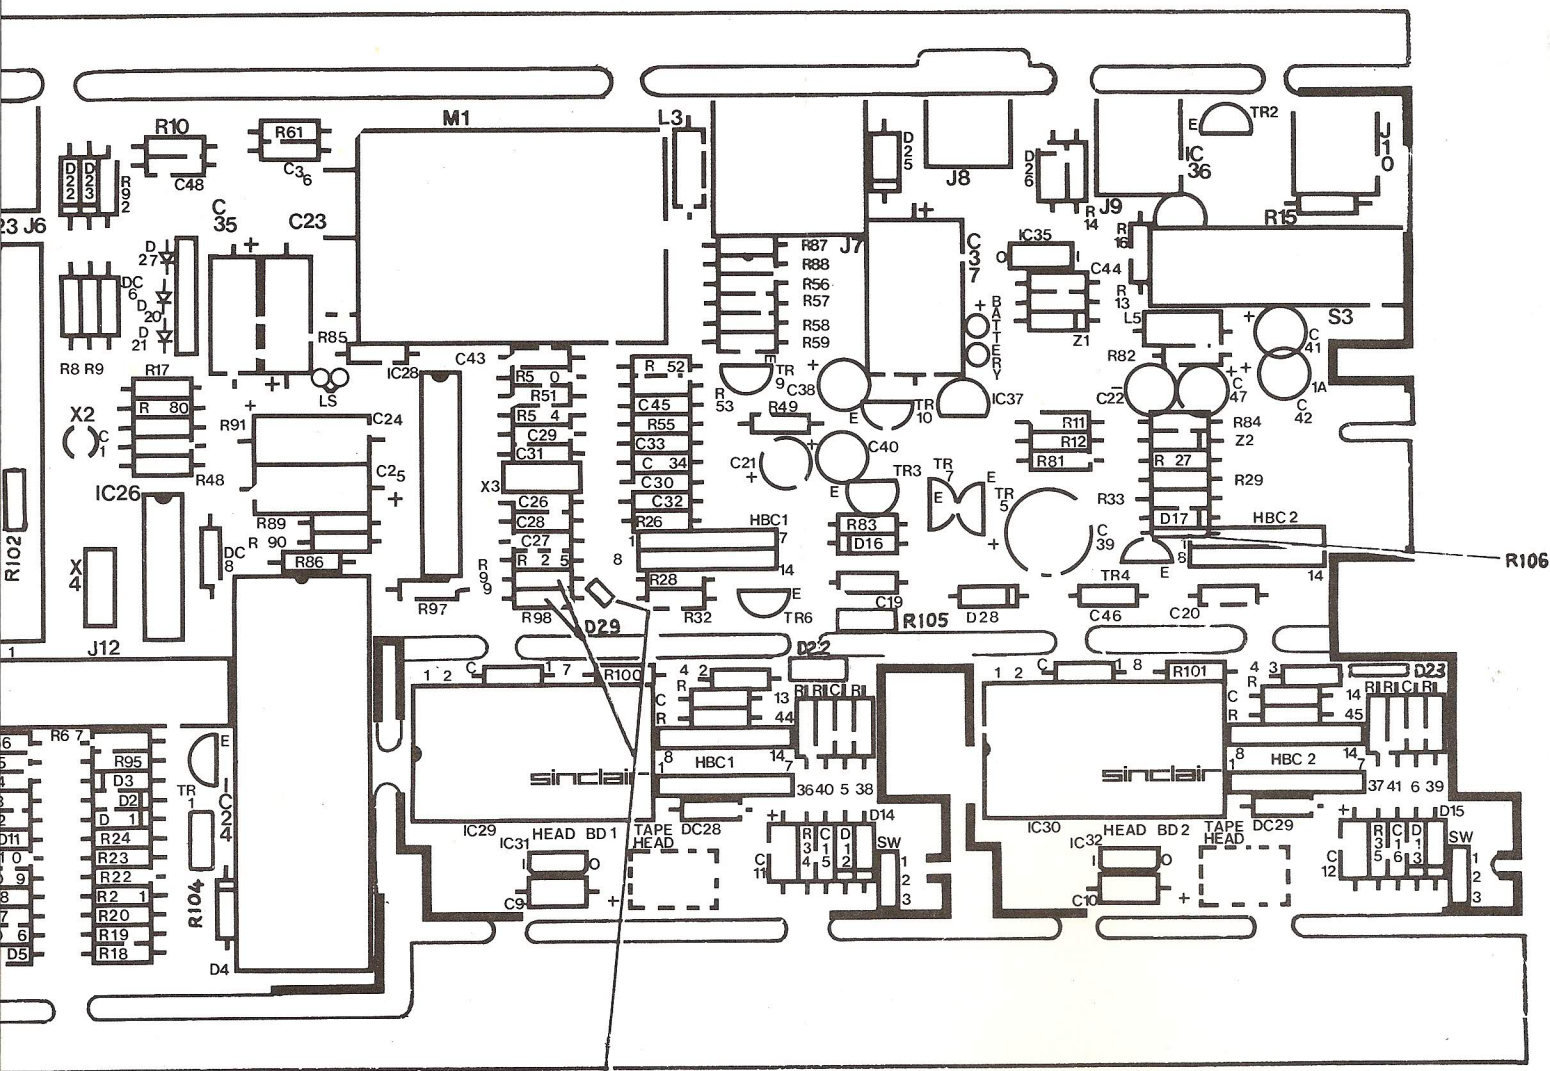
FIGURE 5.1

PRINTED CIRCUIT BOARD (Issue 5)
COMPONENT LAYOUT

1.2.2 A newly laid out p.c.board was introduced at Issue 6 to reflect the removal of IC17 and IC27 and the addition of HAL IC38. Resistors R102, R103 and R104 were added at this stage and trimming capacitor TC1 was replaced with a fixed capacitor C53 of 22pF. The parts list reflects minor changes to component values. Board layouts are shown in Figures 5.1 and 5.2.

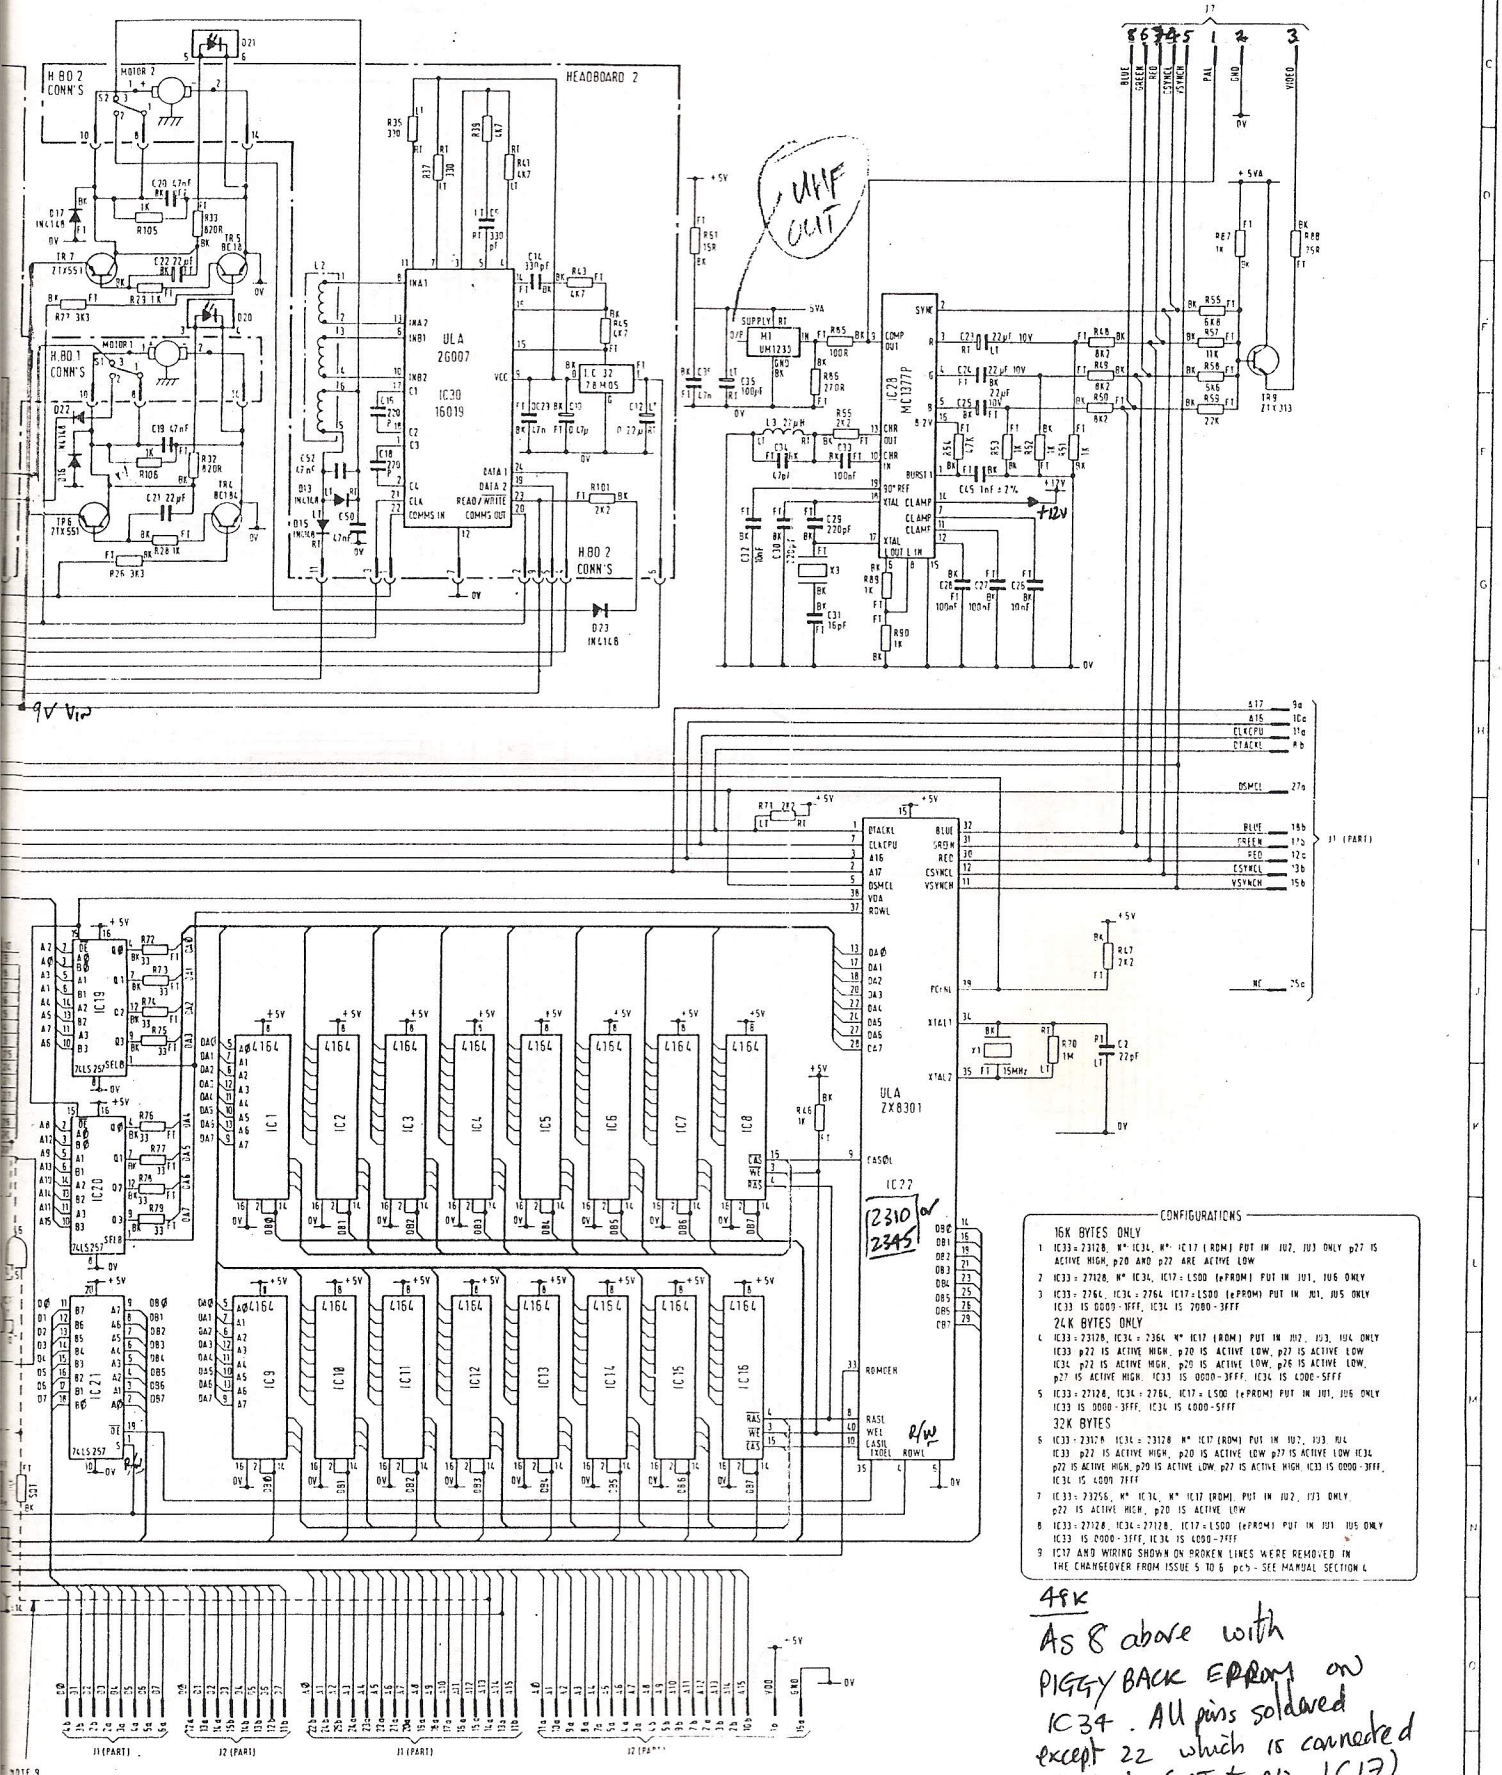
FIGURE 1.4 QL CIRCUIT DIAGRAM (Issue 5) 1.17

- 16K BYTES ONLY**
- IC33 = 2312B, IC34 = 2764, IC17 (ROM) PUT IN J07, J03 ONLY p27 IS ACTIVE HIGH, p20 AND p22 ARE ACTIVE LOW
 - IC33 = 2712B, IC34 = 2764, IC17 = LS00 (+PRGM) PUT IN J01, J06 ONLY

- IC33 = 2764, IC34 = 2764, IC17 = LS00 (+PRGM) PUT IN J01, J05 ONLY
- 24K BYTES ONLY**
- IC33 = 2312B, IC34 = 2764, IC17 (ROM) PUT IN J02, J03, J04 ONLY
